## **Intermountain Region Risk Management Office** ***Safety and Health Site Visit and Evaluation Report***

Date: September 22, 2004

Re: Carbon Monoxide Exposure Monitoring during CURE Boat Operations

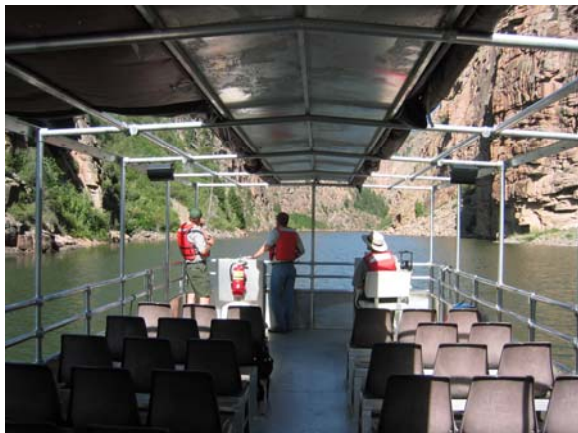
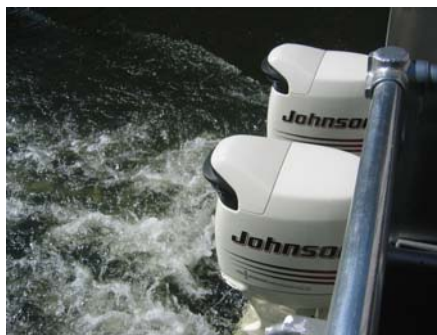
The Pine Creek Tour Boat is powered by twin outboard Johnson Bombardiers at 140 horsepower (HP). Both units are electronic fuel-injected 4-stroke engines. Public tours are offered daily on the boat during the summer season on the Morrow Point Reservoir. Two park staff members typically run the boat; one staff member is the boat operator, while the other provides interpretive information during the ride. Neither operator must spend very much time at the rear of the boat, where the engines are located. Monitoring was conducted on this boat on June 8 because a refueling trip to the Morrow Point Dam was scheduled. Monitoring for CO was conducted for both of the staff members on the boat, Mr. Ron Walton and Mr. Miles Kinne. Monitoring was also conducted for Mr. Bleicher, who remained on the boat during the trip to refuel and the return to the Pine Creek Dock.

**Pine Creek Tour Boat**

**Tour Boat Engines**

During the monitoring period (approximately 8:45am to 1:25pm) instantaneous peak exposures to CO were in the range of 15-65 ppm, while average exposures over the time period ranged from 1 to 2 ppm. An instantaneous reading using a Draeger tube showed a CO level of 5 ppm at the rear of the boat near the engines during normal boat speed. Pre-shift expired breath CO levels were 3 ppm (0.9%) for Mr. Walton and 2 ppm (0.5%) for Mr. Kinne. Expired CO levels were the same at the end of the shift. Based on these results, it is unlikely that employee exposures on the Pine Creek Tour Boat will exceed the required or recommended limits for CO during normal operations. Please see Charts I, II, and III below for complete CO exposure data on these three individuals over the monitoring period.

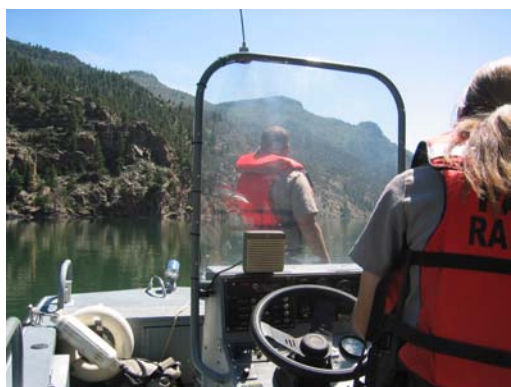
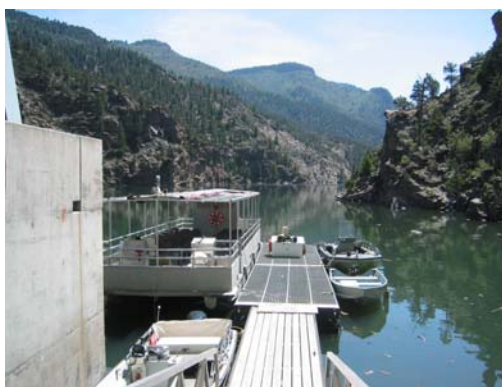
The Morrow Point Ranger Boat that was monitored is a small open craft with an *inboard/outboard (I/O)* Mercruiser Alpha One 3.0 Liter single engine that was not fuel-injected. Two rangers were assigned to the Morrow Point Reservoir during refueling of the Pine Creek Tour Boat. Because refueling is done at the Morrow Point Dam, the security fence on the water protecting the dam must be opened and monitored by the rangers. The two rangers on the boat on June 8 were Mr. Joel Cadoff and Ms. Shawn Cigrand. According to Mr. Cadoff and Ms. Cigrand, boat rangers typically spend about 1-5 hours per day on the water during patrols and other activities. They indicated that the rangers can also do some scuba work when needed for recovery operations. However, Chief Ranger Linda Alick indicated that no one in the park is currently certified for SCUBA operations, and therefore this type of work is not currently being done at the park. On this particular day Mr. Cadoff and Ms. Cigrand monitored the dam and the dam security fence during refueling, and then conducted a routine patrol on the Morrow Point Reservoir. CO monitoring data was collected for Ms. Cigrand, Mr. Cadoff, and also Ms. Sahmel who rode in the ranger boat following refueling of the tour boat and during the ranger patrol.

**Morrow Point Ranger Boat**

**Ranger and Tour Boats at Dam**

During the monitoring period (approximately 10:35am to 12:35pm) instantaneous peak exposures to CO exceeded the 8-hour exposure alarm on the monitoring equipment, but did not exceed the allowable exposure limit for the entire monitoring period. The NIOSH Ceiling REL of 200 ppm was exceeded on two occasions. Peak exposures ranged from 75 to 275 ppm. Exposures were highest during boat engine warm-up at the dam dock, during closure of the dam security gate and during any slow-speed idle. When the boat moved at higher speeds on the water, exposures dropped to 0-1 ppm. Eight-hour average exposures were 1-5 ppm. End of shift expired breath CO levels were 5 ppm (0.9%) for Mr. Cadoff, 4 ppm (0.7%) for Ms. Cigrand, and 3 ppm (0.5%) for Ms. Sahmel. These levels are considered consistent with normal background concentrations of CO. Although 8-hour exposures were not exceeded, it is likely that rangers working on this type of boat will regularly exceed the NIOSH Ceiling REL of 200 ppm. Please see Charts IV, V, and VI below for complete CO exposure data on these three individuals over the monitoring period.

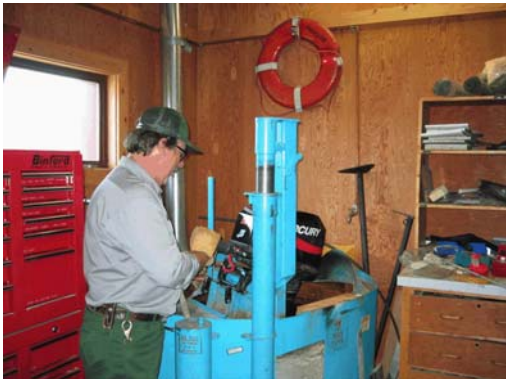
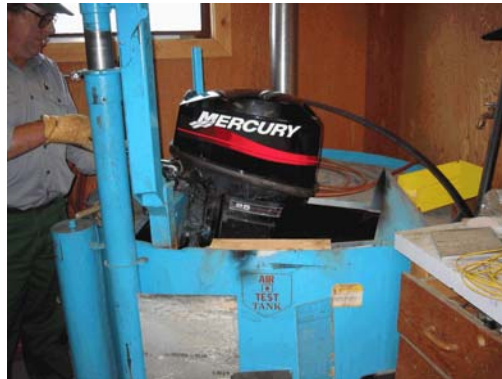
The boat maintenance shop at Elk Creek is a large, 4-bay enclosed shop dedicated to boat maintenance. Mike Kinkead is the primary boat mechanic, and does the majority of boat engine repair and maintenance for the park at his shop. Mr. Kinkead indicated that he only runs boat engines inside the shop when they are placed inside a ventilated engine test tank in the northwest corner of the shop. He indicated that all engines must be submerged in water in order to run. The engine test tank is a boat engine-specific ventilation system made by Specialty Motors Manufacturing. It is a fully enclosed tank and ventilation duct, with an opening only at the point where engines can be placed into the tank using a hydraulic lift.

Engine Test Tank in Boat Maintenance Shop

Ventilated Test Tank

With the ventilation system running and the test engine at an idle, CO measurements were taken outside the tank in the breathing zone of the operator and were found to be 0 ppm. With the test engine revved up to full throttle, the CO concentration reached 32 ppm. Mr. Kinkead indicated that he will typically run an engine in the test tank for approximately 2 minutes at any given time, and that the boat engine that was used during the test is typical of the type of engine that he would normally test in the tank. These measurements indicate that the ventilation system is currently adequate for the needs of the shop. As a test to determine the effectiveness level of the ventilation system, CO concentrations were also measured with the ventilation system off, and the test engine revved to full throttle. The concentration in the breathing zone of the operator reached 277 ppm within 5 seconds, and spike up to 800 ppm within a minute. This test showed that the ventilation system must always be used when operating engines inside the shop. Mr. Kinkead also indicated that many of the boat motors in the park cannot be tested in the test tank in the shop because they are too large. These must be tested in the water at one of the marinas.

- **In the maintenance shop if the test tank ventilation system is turned off:** in the maintenance shop, CO levels spiked up to 277 ppm within only 5 seconds if a boat engine was idled in the shop without the test tank ventilation system on.

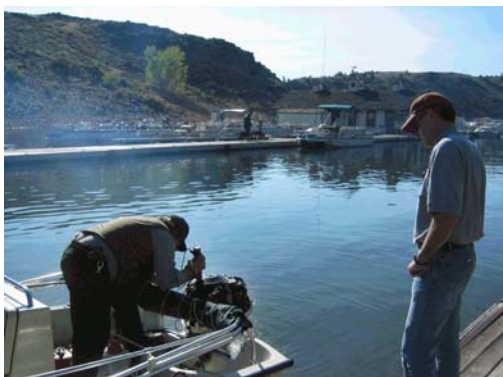
On June 9, 8:20-8:35am, Mr. Kinkead conducted testing and maintenance on the Interpretation staff boat, a Boston whaler with an outboard Johnson 90 HP engine. He took the boat to the Elk Creek marina boat ramp to test the engine. During engine testing, CO levels in the breathing zone of Mr. Kinkead quickly reached 87 ppm at lower engine speeds, and rose above 150 ppm at higher engine speeds. The average concentration during the maintenance work, which lasted about 10 minutes, was approximately 20 ppm. The short duration of this particular exposure meant that exposure levels of concern were not reached. Please see Chart VII for Mr. Kinkead's total exposures during maintenance activities.

Maintenance Work at Elk Creek Marina

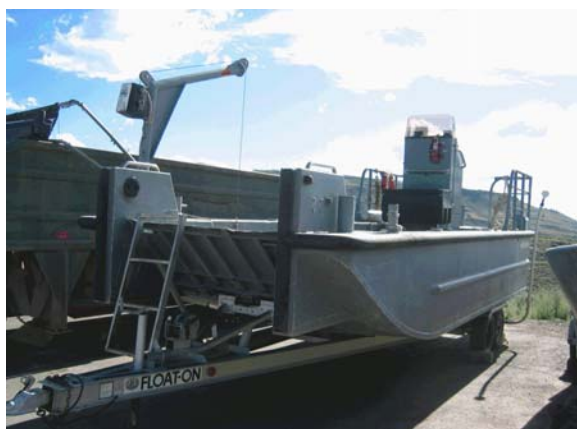
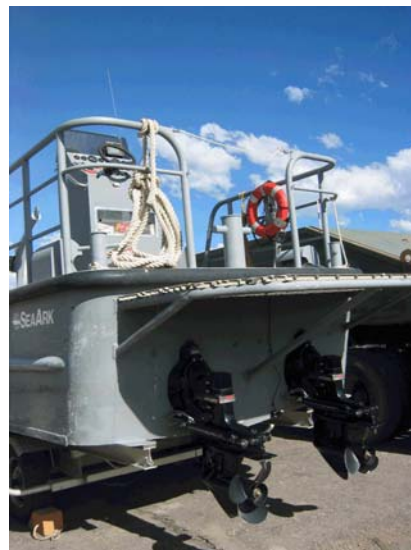
The Curecanti Maintenance Barge is a large metal barge with twin 3-Liter Mercruiser inboard/outboard engines. Each of the engines is 130 HP, and is carbureted rather than fuel-injected. Mr. Kinkead put in the boat at 9:35am, and ran the bilge fans for approximately 5 minutes before starting the engines. This barge is used for maintenance activities on the Blue Mesa Reservoir, such as dock maintenance. Mr. Kinkead indicated that he may operate this boat for anywhere from several minutes to several hours a day. Additionally, noise levels were measured on this boat and were also

found to be a potential concern. Levels ranged from 87 to 92 decibels on the A-weighting scale (dBA) while running at higher speeds, and from 71 to 80 dBA when running at lower speeds. The OSHA and NPS Action Level for noise exposure is 85 dBA over an 8-hour period, which could potentially be reached during longer operations on the barge.

**Maintenance Barge**

**Maintenance Barge Engines**

Immediately after starting the engines at 9:42am, CO levels in the rear of the barge at the operator's controls quickly reached 800 ppm, four times the NIOSH Ceiling REL. Levels remained in the range of 250-750 for approximately 10 minutes. Following startup of the barge and during movement on the barge, levels dropped to 0-60 ppm for the operator. Mr. Kinkead's time-weighted average exposure during all boat maintenance activities was 7 ppm, and his end of shift expired breath CO level was 4 ppm (0.7%), which was consistent with normal background levels of CO. Although Mr. Kinkead's exposure did not exceed 8-hour exposure levels, it greatly exceeded the NIOSH Ceiling REL of 200 ppm. Please see Chart VII below for complete CO exposure data for Mr. Kinkead over the monitoring period.

- **On the maintenance barge during startup:** CO levels during startup of the maintenance barge reached over 800 ppm within several seconds, an extremely dangerous level.

- The maintenance barge should be taken out of service and modified *or updated* as soon as possible to lower CO exposures during startup. CO exposure levels for the operator were very dangerous, and were measured at four times the NIOSH Ceiling REL of 200 ppm. Changing out the engines is the most likely modification that will effectively reduce CO exposures, although other modifications may also be effective.

- *Ensure that the park's boat preventive maintenance program considers all CO exposure concerns and issues as appropriate, and that boat engines with high CO levels (primarily carbureted engines) are prioritized for replacement.*

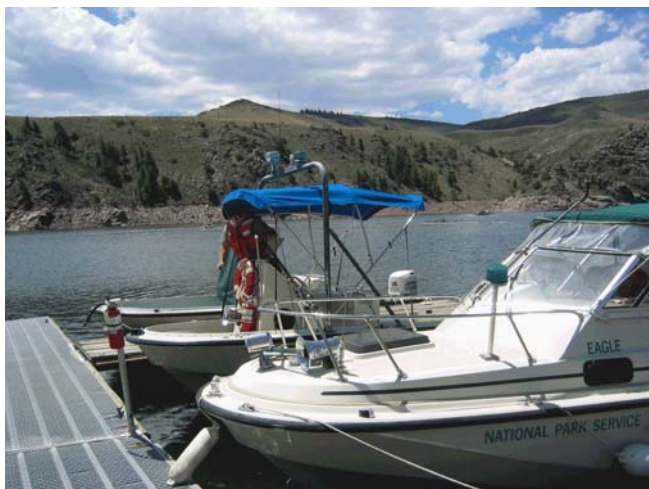
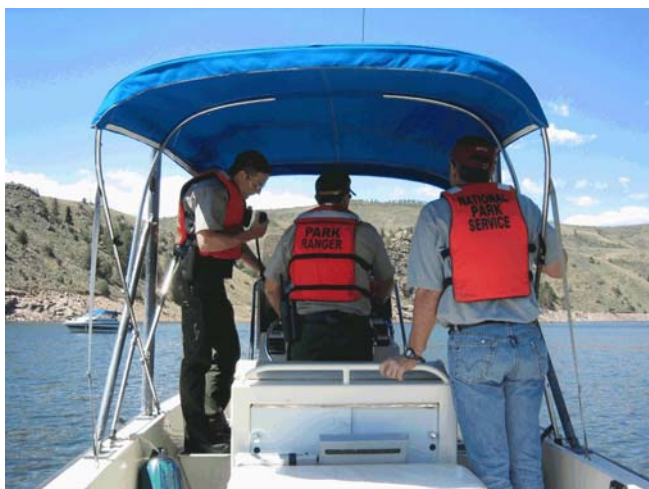
**Boston whaler:** During engine startup, CO levels were low (0-1 ppm) on the Boston whaler. CO levels remained low at all speeds across the water, until the boat was idled to maintain a specific position and communicate with other boats. CO levels quickly rose to 50 ppm during idling, and peaked at 376 ppm during one routine contact session with another boat. Wind direction was directly linked to CO levels in the boat passengers' breathing zone, and CO levels appeared to be highest when the boat was directly in line with the wind. When the boat was idled at an angle to the wind direction, CO levels remained much lower.

**Cabin cruiser:** During engine startup, CO levels rose higher than on the Boston whaler. Levels were measured in the range of 45-90 ppm in the middle of the boat. However, when the wind direction and speed changed slightly, the CO level quickly rose to between 375 and 400 ppm, especially while backing the boat away from the dock. The wind speed is a particularly important issue on the cabin

cruiser, because when the wind blew from the rear of the boat directly into the cabin, CO levels spiked above 450 ppm in under a minute. This is potentially a very dangerous situation because the CO concentrations can build up in the cabin and remain high for longer periods of time.

**The Two Ranger Boats at Elk Creek Marina**

**Boston Whaler Ranger Boat**

- **On the ranger patrol boats on the Blue Mesa Reservoir for certain wind directions:** On the ranger patrol boats in the operator area, levels spiked as high as 380 ppm *at the operator* location *and as high as 450 ppm in the cabin*, during routine patrols, especially when the wind blew from the back of the boat.

- Inform all employees, volunteers, and contractors that wind direction appears to have a strong effect on CO exposures and concentrations on the ranger patrol boats and other boats on the reservoir. According to the rangers, the wind speeds on the Blue Mesa Reservoir are commonly in the range of 35-40 mph. Even at these speeds, CO levels would quickly build up in the operator area of the boat to well above 200 ppm when the wind *is* blowing directly into the boat from the rear. This is of especially high concern for the cabin cruiser, because CO levels can build up and remain high in this enclosed space at dangerous levels.

- Install marine CO detectors on all boats at Curecanti. These should have an audible and visible alarm to alert the operator when CO levels become dangerously high on the boat.

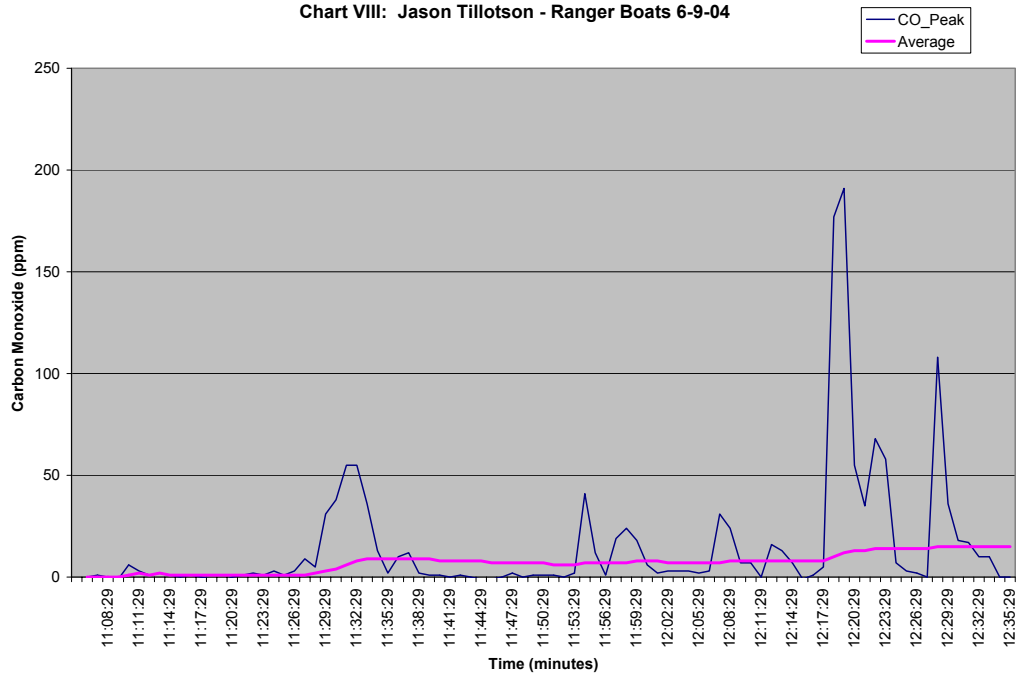
Chart VIII: Jason Tillotson - Ranger Boats 6-9-04

During the monitoring period on June 9, Mr. Tillotson's time-weighted average exposure was 3 ppm, and his peak exposure was 191 ppm. Mr. Cadoff's time-weighted average exposure was also 3 ppm, and his peak exposure was 281 ppm.

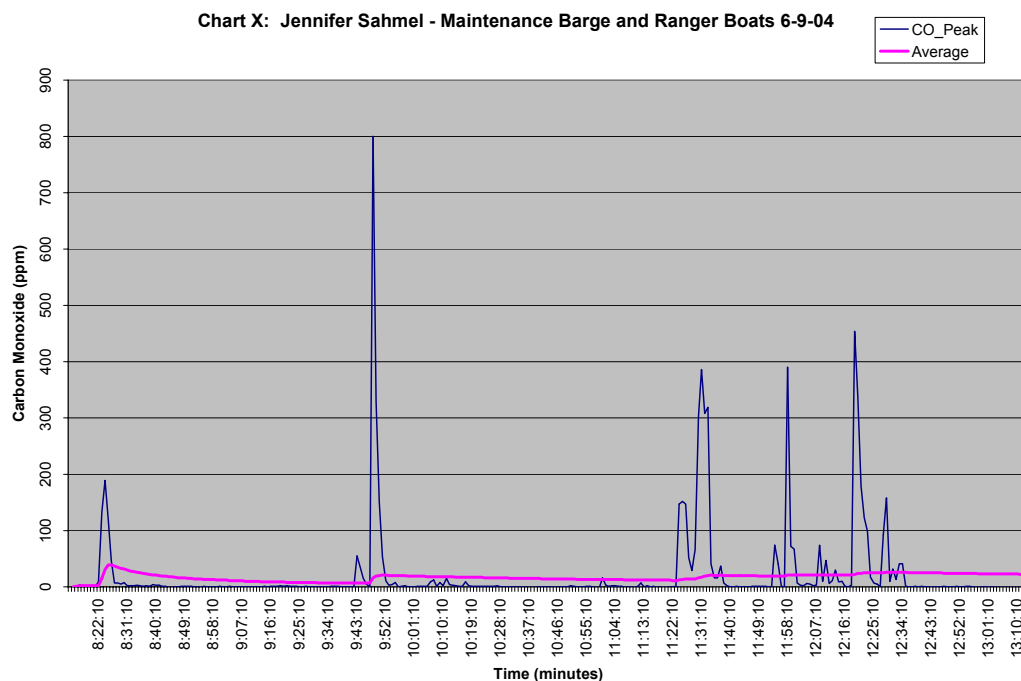
For the combination of maintenance activities with Mr. Kinhead and ranger patrol activities with Mr. Tillotson and Mr. Cadoff, Ms. Sahmel's time-weighted average exposure was 14 ppm, with a peak exposure of 800 ppm on the maintenance barge and 454 ppm in the cabin of the cabin cruiser. Mr. Bleicher's time-weighted average exposure was 11 ppm with a peak exposure of 463 ppm on the maintenance barge and 246 ppm on the ranger boats.

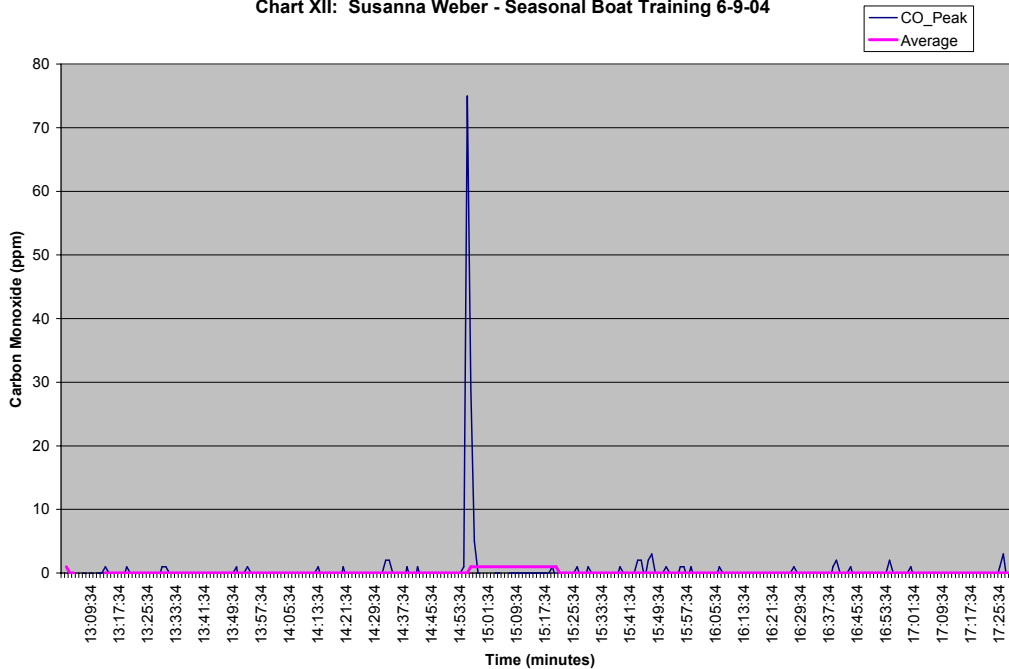
Chart XII: Susanna Weber - Seasonal Boat Training 6-9-04

Seasonal boat training was being conducted at the park on June 9. Two of the students, Colleen Ross and Susanna Weber, volunteered to monitor their CO exposure during the course, which involved both training time on land and in a boat. During the June 9 class sessions, Ms. Ross did not actually get onto any of the park boats. Ms. Weber did spend some time on a boat, and had some CO exposure during the training. Her peak exposure during the training was 70 ppm. Please see Chart XII for Ms. Weber's complete exposure.
